Highway Accident Report
Central Texas Bus Lines, Inc.
Charter Bus, State Route 7 Near
Jasper, Arkansas, June 5, 1980

(U.S.) National Transportation Safety Board
Washington, DC

1. Report No. NTSB-HAR-81-1	2. Government Accession No. PB81-178410	3. Recipient's Catalog No.	
4. Title and Subtitle Highway Accident Report--Central Texas Bus Lines, Inc., Charter Bus, State Route 7, near Jasper, Arkansas, June 5, 1980		5. Report Date January 21, 1981

**CENTRAL TEXAS BUS LINES, INC., CHARTER BUS
STATE ROUTE 7
NEAR JASPER, ARKANSAS
JUNE 5, 1980**

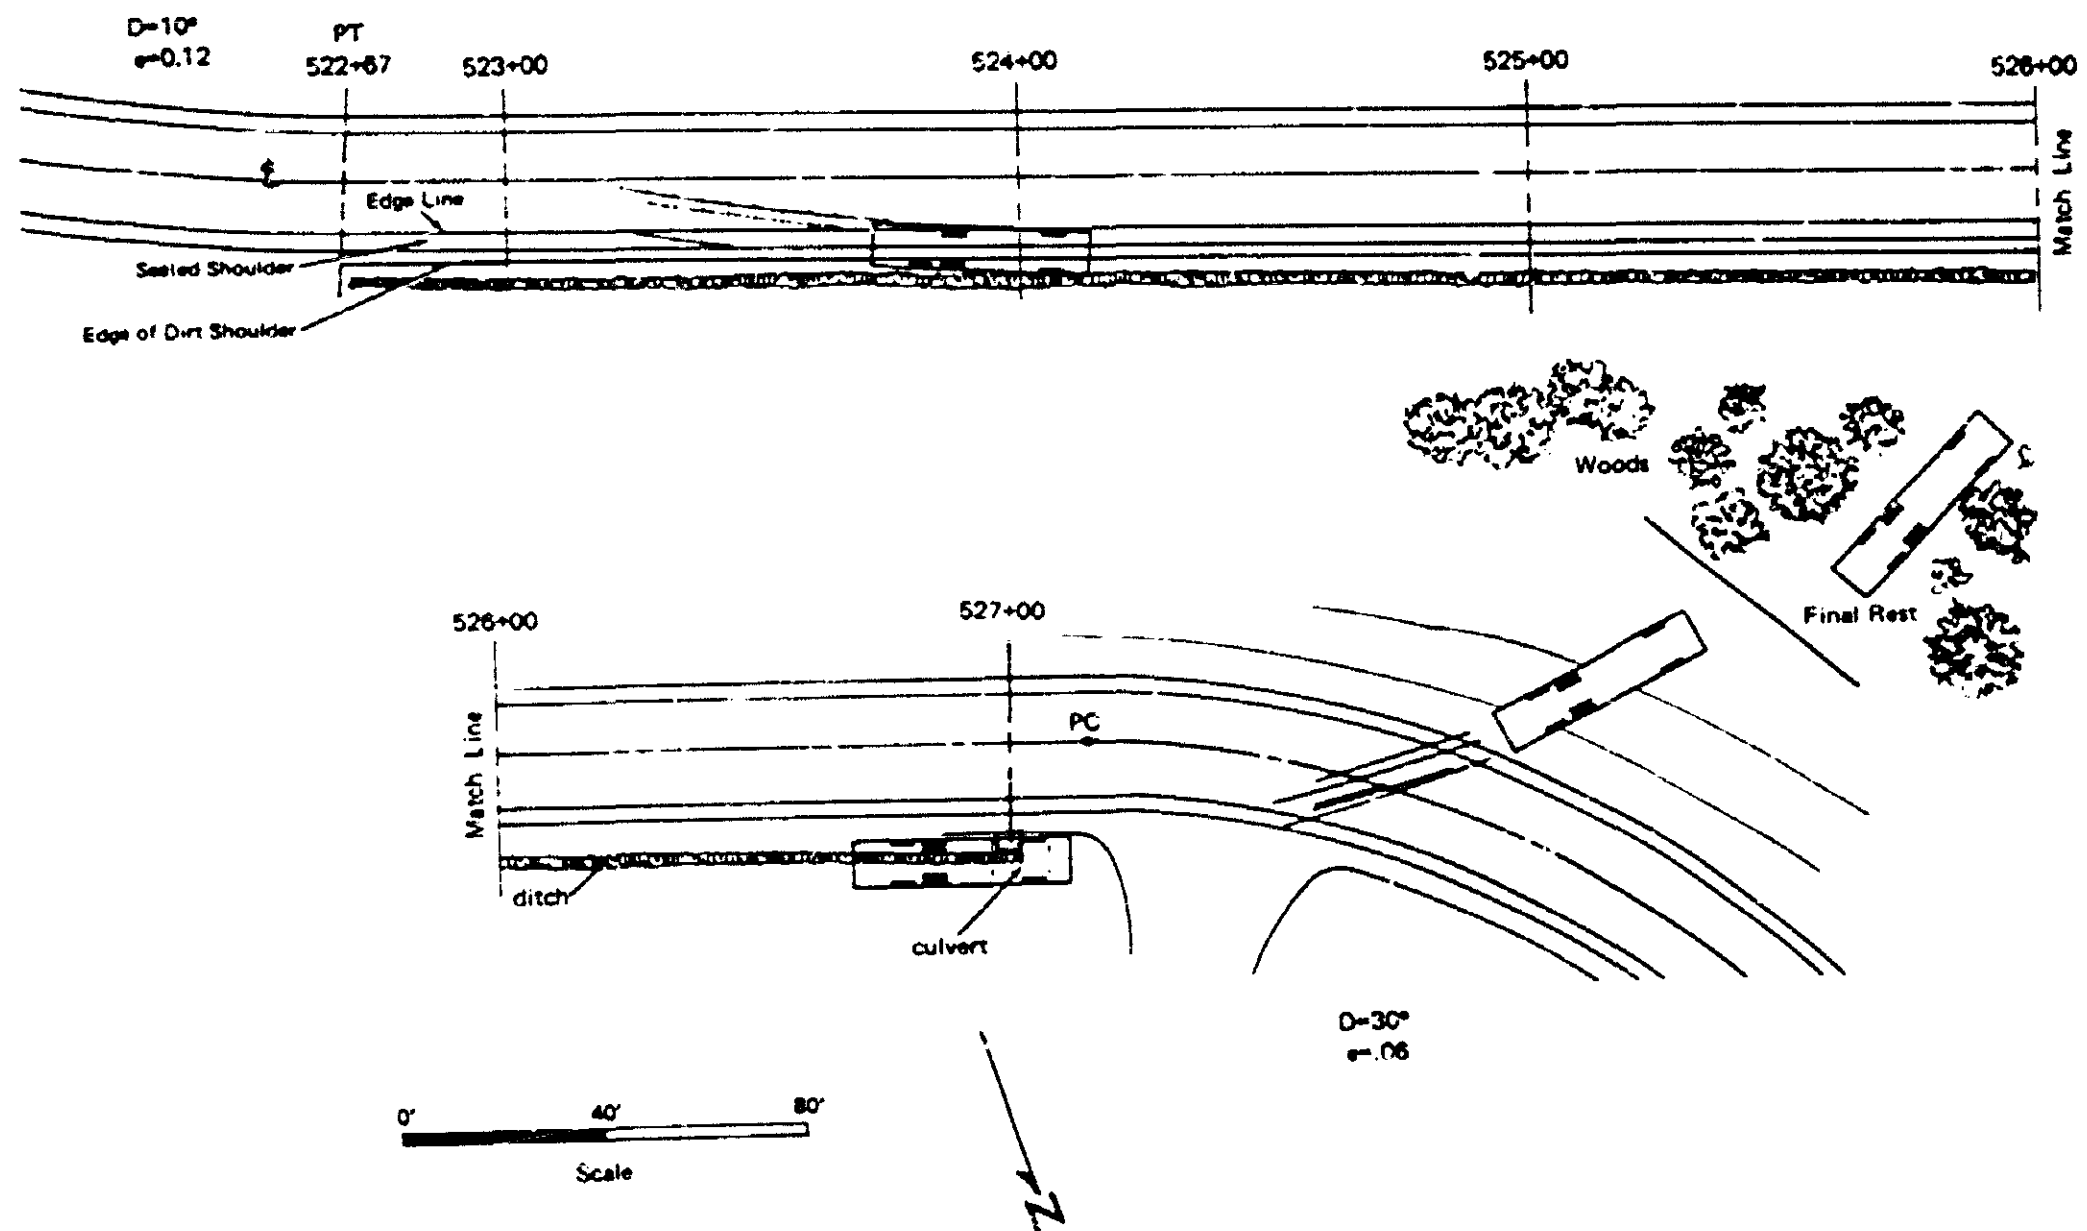
Figure 1.--Plat of accident site.

About 2 miles north of the hillcrest, the bus entered a 0.2-mile-long construction zone. The construction zone began with a 10-degree right curve followed by a straight section which was followed by a 10-degree left curve. A runaway vehicle escape ramp was being constructed on the straight section of the existing roadway, and the traveled way had been realigned to the west of and roughly parallel to the escape ramp. The bus traversed the construction zone but failed to negotiate the 10-degree left curve and ran off the right pavement edge into a drainage ditch which paralleled the road. A steep hillside with several rock outcroppings formed the right bank of the ditch, and as the right wheels of the bus entered the ditch, the bus tipped and its right side began scraping along the hillside. The bus continued forward for about 280 feet. (See figure 1.)

About 120 feet north of where it first contacted the hillside, the right-side window area struck a large rock outcropping. The bus then struck and mounted a 3-foot-high berm located at a concrete culvert headwall, and the busdriver and two passengers were ejected. The impact redirected the bus diagonally to the left across the pavement and off the left pavement edge. Two more passengers were ejected during this travel. The bus launched into a vault as the roadside terrain descended rapidly. The front of the bus struck several trees with bole diameters ranging from 9 to 13 inches. Two of these trees were sheared; three were uprooted. The bus came to rest (see figure 2) with its front against a large rock about 38 feet below pavement level where several more passengers were ejected.

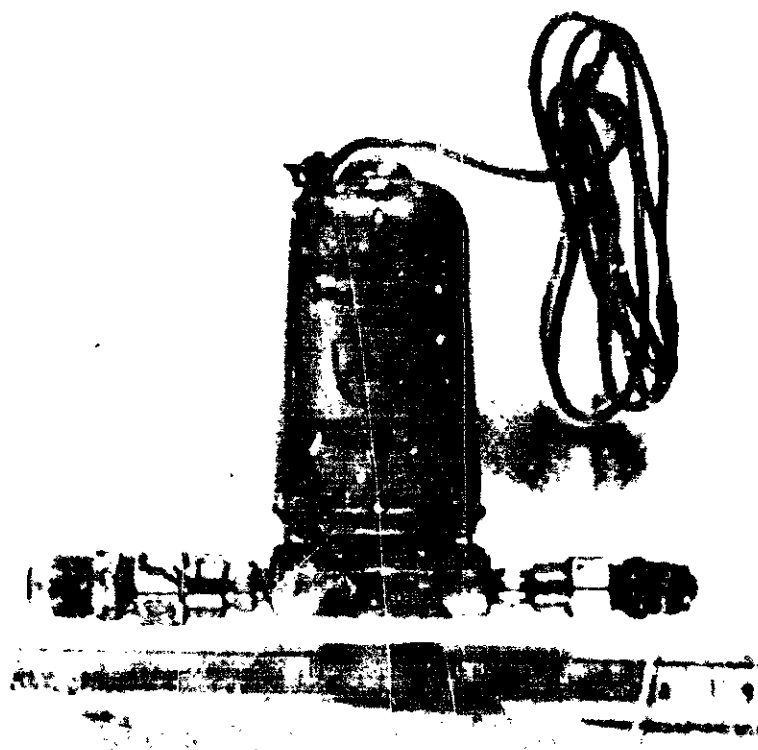
Fuel Pump.--The nonstandard fuel pump installed in Oklahoma was an electric centrifugal pump which had a constant flow rate of 22 gallons per hour at 1 psi and an outlet pressure of 4 to 8 psi. (See figure 3.) It had been installed so as to bypass the original equipment diesel fuel pump which had a broken shaft. The replacement fuel pump was the type normally used for gasoline automobile engines. The original equipment diesel fuel pump was a speed-sensitive, vacuum-mechanical, positive-displacement pump with a 110 to 115 gallon per hour flow rate and an outlet pressure of 70 psi at 2,100 rpm.

Figure 3.--Nonstandard electric fuel pump and attaching hardware used on accident vehicle.

The original fuel pump on the bus was a speed-sensitive, positive-displacement pump that increased fuel volume and pressure to accommodate increased engine loads and speeds. The small electric replacement fuel pump had only 20 percent of this fuel flow capability and could not supply sufficient fuel to the engine.
