Highway Accident Report
Central Texas Bus Lines, Inc.
Charter Bus, State Route 7 Near
Jasper, Arkansas, June 5, 1980

(U.S.) National Transportation Safety Board
Washington, DC

1. Report No. NTSB-HAR-81-1	2. Government Accession No. PB81-178410	3. Recipient's Catalog No.	
4. Title and Subtitle Highway Accident Report--Central Texas Bus Lines, Inc., Charter Bus, State Route 7, near Jasper, Arkansas, June 5, 1980		5. Report Date January 21, 1981

**CENTRAL TEXAS BUS LINES, INC., CHARTER BUS
STATE ROUTE 7
NEAR JASPER, ARKANSAS
JUNE 5, 1980**

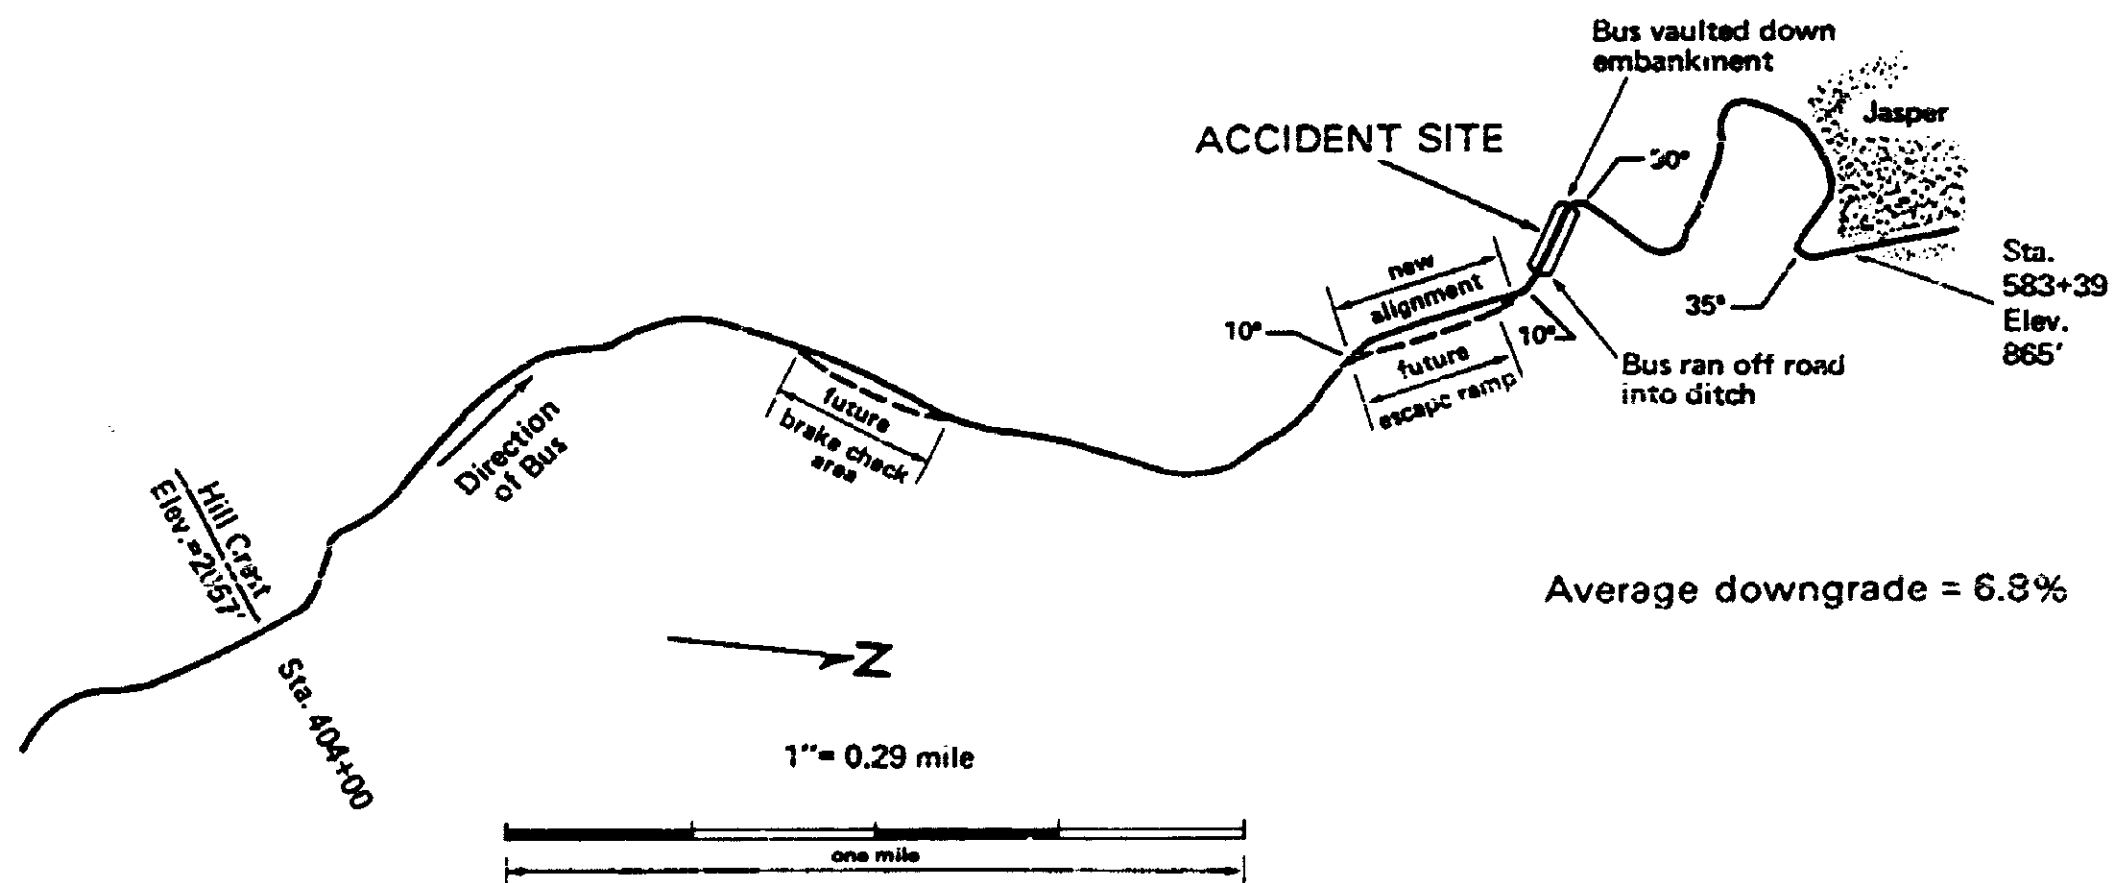
Figure 10.--Plan view of roadway.

The accident site was about 3.2 miles north of the hillcrest. (See figure 10.) The State had recently completed construction of a brake check area 0.9 mile north of the hillcrest, but the area was neither marked, signed, nor in use at the time of the accident. The brake check area was to be opened when a vehicle escape ramp under construction 1.1 miles farther north was completed. The ramp was being built on the existing alignment of Route 7, and the roadway had been realigned west of and roughly parallel to the ramp. The detour was opened to traffic the day before the accident. (See figures 11 and 12.)

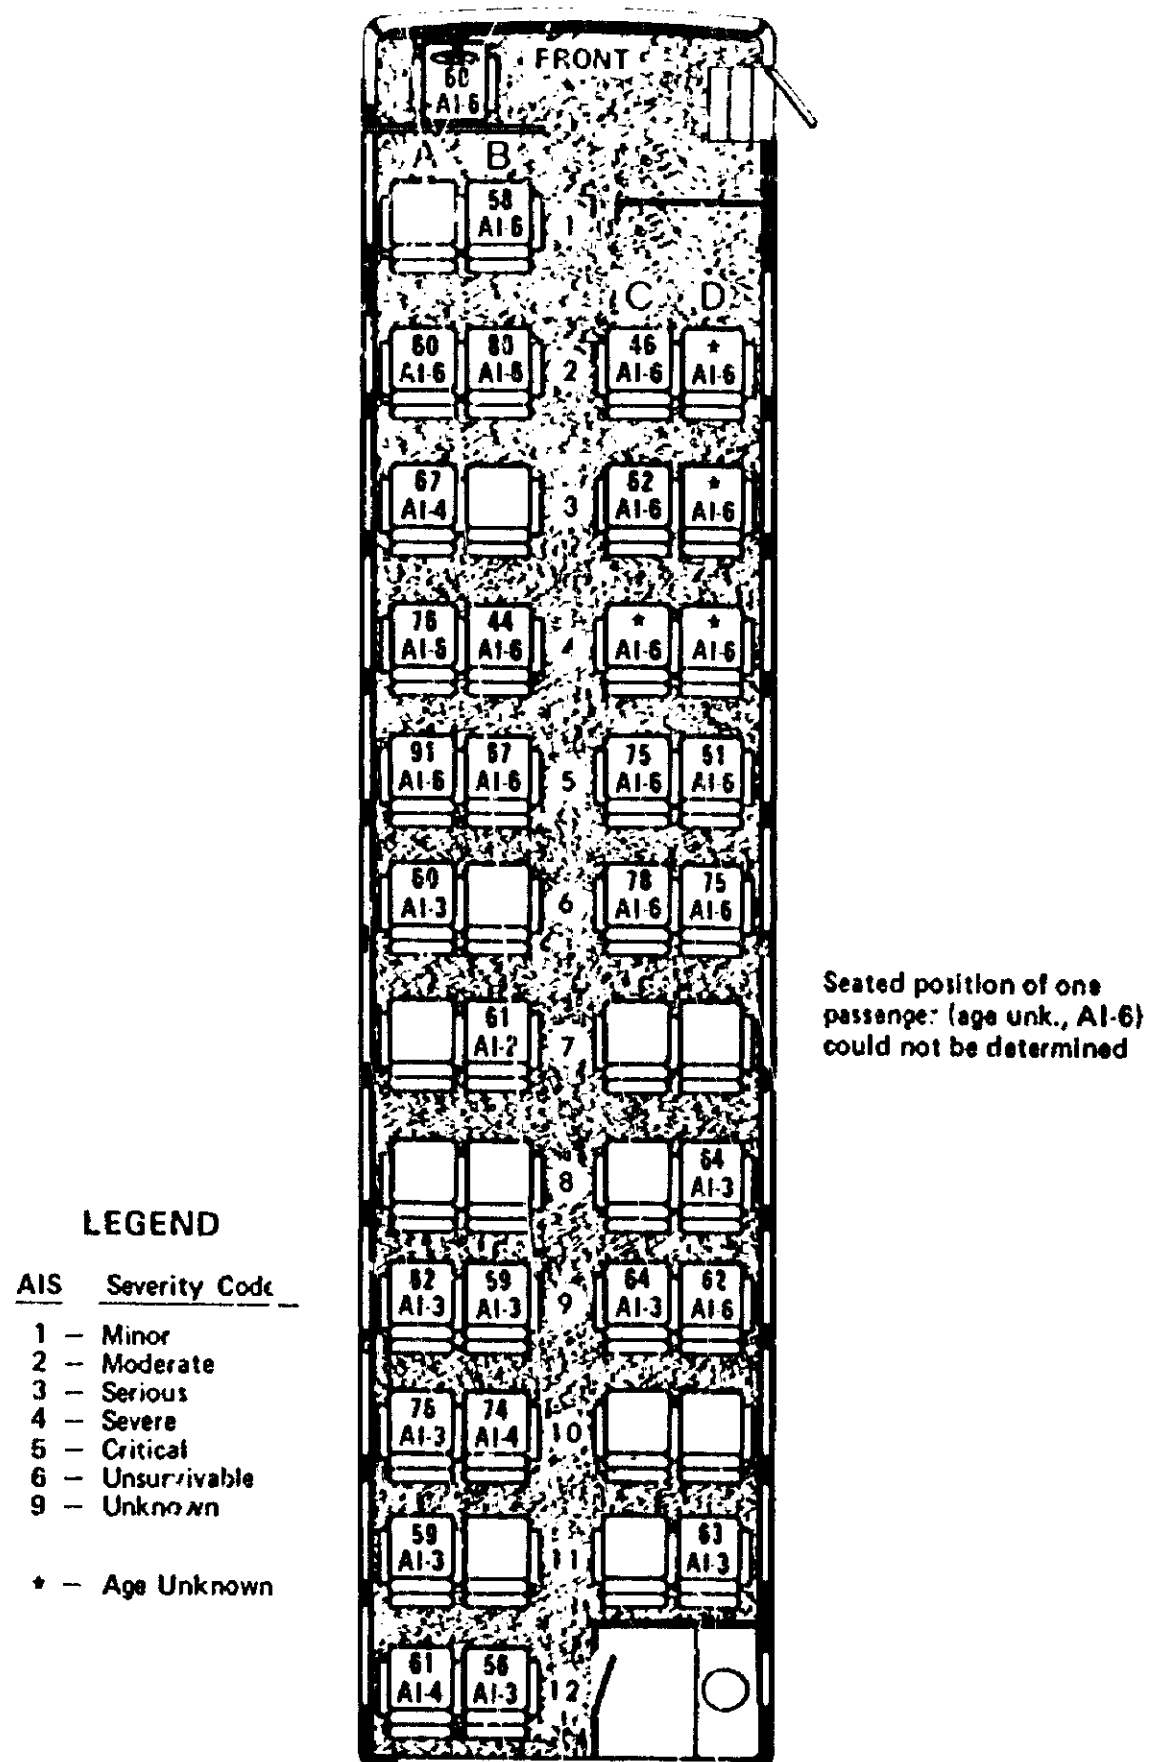
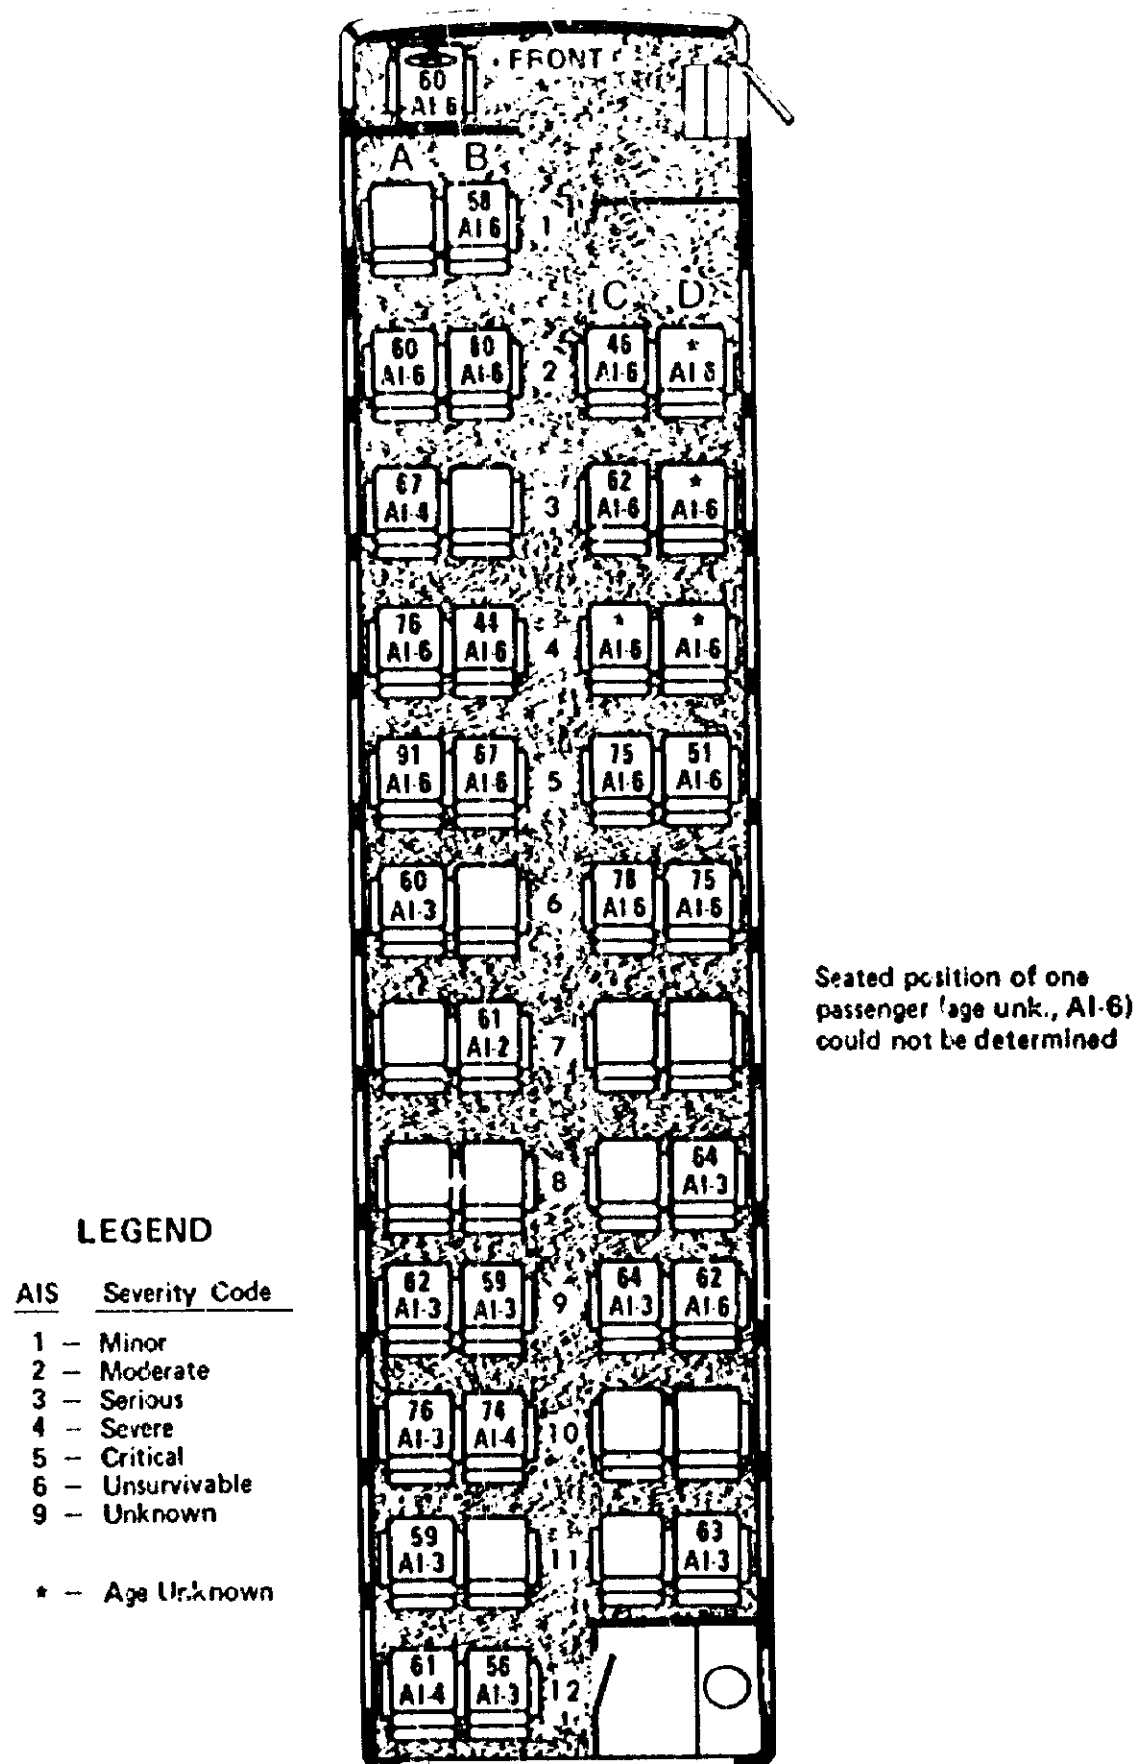
Figure 13.--Bus occupant seating diagram and injury classification.

The ages of the bus occupants ranged from 44 to 91 years. (See figure 13 for the age, seat position, and degree of injury to the bus occupants.)
